## Assessment of a Mechanical Failure in a Historic Wood Truss Using Digital Radioscopy

**Ronald W. Anthony<sup>\*</sup>, Edmund P. Meade<sup>\*\*</sup>**

Anthony and Associates, Inc. <sup>\*</sup>, Robert Silman Associates, P.C. <sup>\*\*</sup>

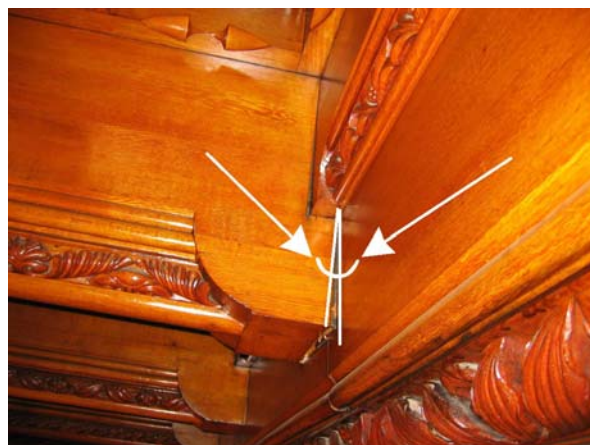
**Figure 1.** Open joint in the decorative trim of the lower chord of truss #3.

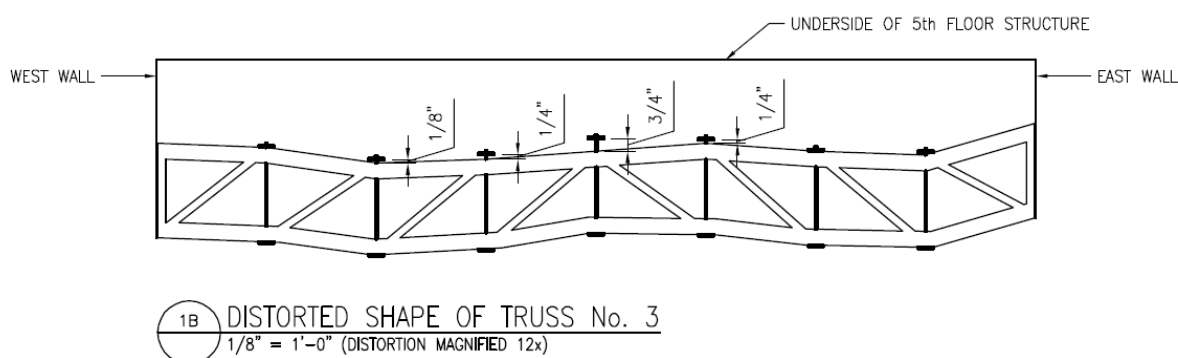
RSA made subsequent visits in 2004 and noted some unusual reverse curvature to the top chord of truss #3 (visible from the attic and shown schematically in Figure 2.). Because the bottom chords of each ceiling truss were covered by the ceiling's historic wood veneer and were hidden from above by insulation, RSA was unable to obtain a complete understanding of the detail and condition of the lower portions of the trusses.

**Figure 2.** Schematic of the deflection of truss #3 in the New York State Senate Chamber.

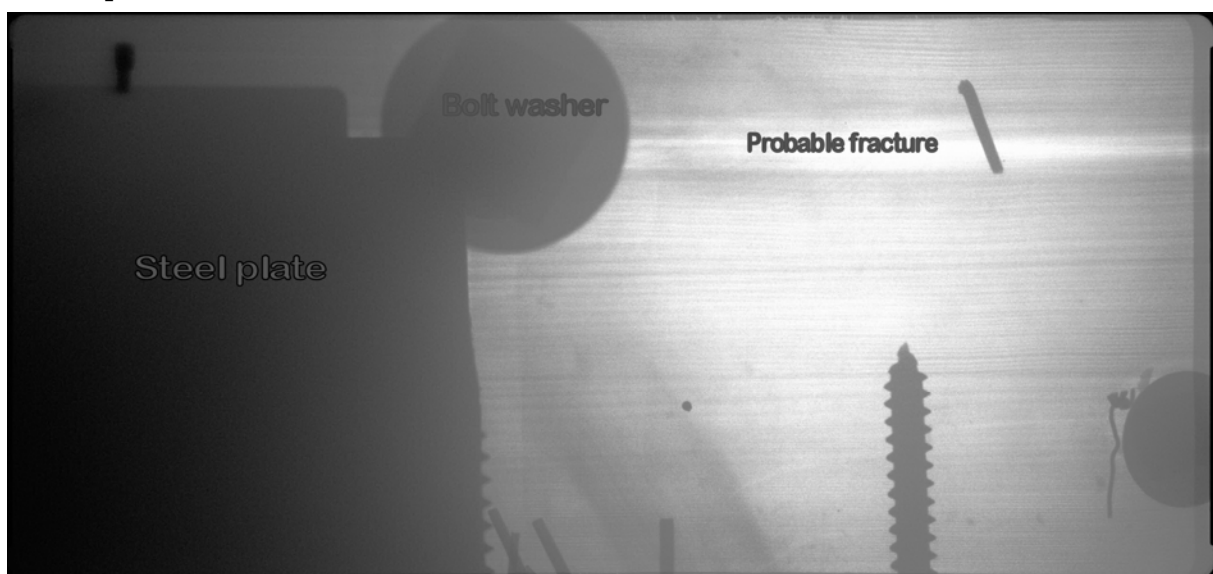
**Figure 9.** Radiograph of exposure #1

- Steel plates were present below where purlins 6 and 8 intersect the truss.
- Vertical threaded rods were visible at purlins 6 and 8.
- No steel plate was present below purlin 7 at the truss.
- A wood diagonal truss chord was visible at purlin 6.
- A probable fracture (as opposed to a seasoning check in the lumber due to drying) was visible in shots 15, 1, 14, 13 and 12 (proceeding from west to east). The fracture extends from west of purlin 8 to west of purlin 6.
-

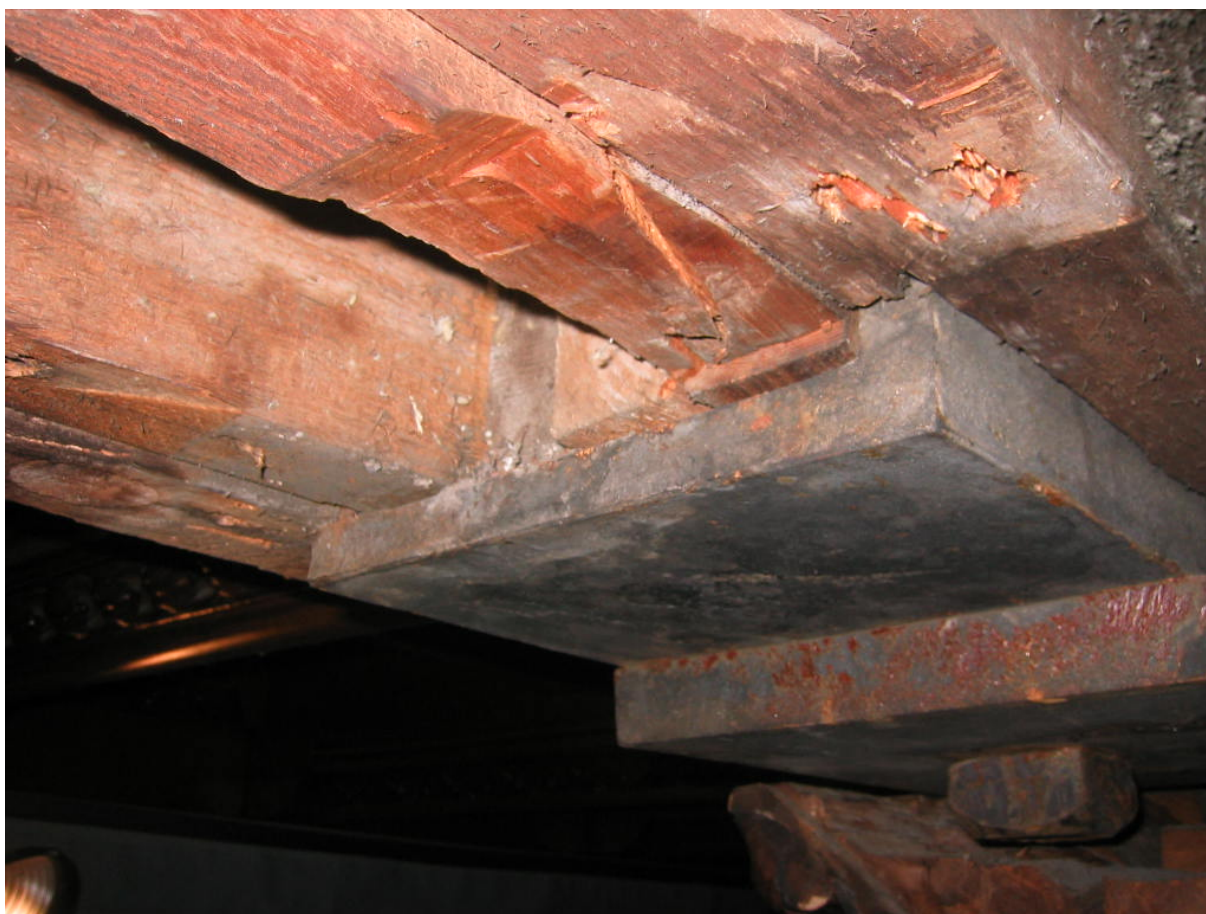
At this evidence of a fracture in the bottom chord, RSA requested that the historic veneer be removed to confirm the distress and to expose the entire bottom chord of the truss where additional distress may occur. The veneer was removed under the supervision of the architectural office of Einhorn Yaffe Prescott. On 28 November 2005 RSA was on site to find a total failure in the northern member of the bottom chord (Figures 11 and 12). The location of the failures is west of center, less than a cm west of the last x-ray image taken. The crack documented by the x-rays was an overstressed response of the southern member to the complete failure of its companion.

**Figure 11.** Split bottom chord, east end of failure

The distress in truss #3 appeared to be related to several factors: the absence of adequate lateral bracing to the top (compression) chord of the truss, the presence of some lateral rotation of the truss, and the introduction of some additional loads from mechanical equipment and lights in the attic above the ceiling. There were no obvious signs of poor construction (such as visible splitting of the wood or substandard condition of connectors).

The short period of time available for the repair limited the options for repair or replacement. Due to the utter failure of truss #3, reinforcement of the original wood member was not a feasible option. RSA provided schematic designs for a steel companion or sistering trusses to carry the existing timber truss and all of the associated loads. These schematics were reviewed on site by RSA, senior representatives of the State of New York, and three local steel fabricators and erectors to assess constructability in such tight quarters. The design was refined based on field observations and refined again based on the fabricators field measurements. The shop drawing production and review process was expedited resulting in a same day turn around for revisions. The design and fabrication of the structural repairs to truss #3 was a collaborative undertaking that took into account the thoughts and comments of each responsible party.

Repairs to truss #3 included the fabrication of new steel truss that would be installed beneath the top chord and above the bottom chord of the existing wood truss. The new steel elements included new steel 10.2 cm x 10.2 cm x 0.64 cm tube sections for the top chord, new 10.2 cm x 5.1 cm x 0.64 cm vertical tube sections, and new diagonal steel rods with threaded ends and clevises. It was also recommended to the State of New York that inspections and repairs of the other trusses in the Senate Chamber ceiling be conducted. That work is scheduled for 2008.

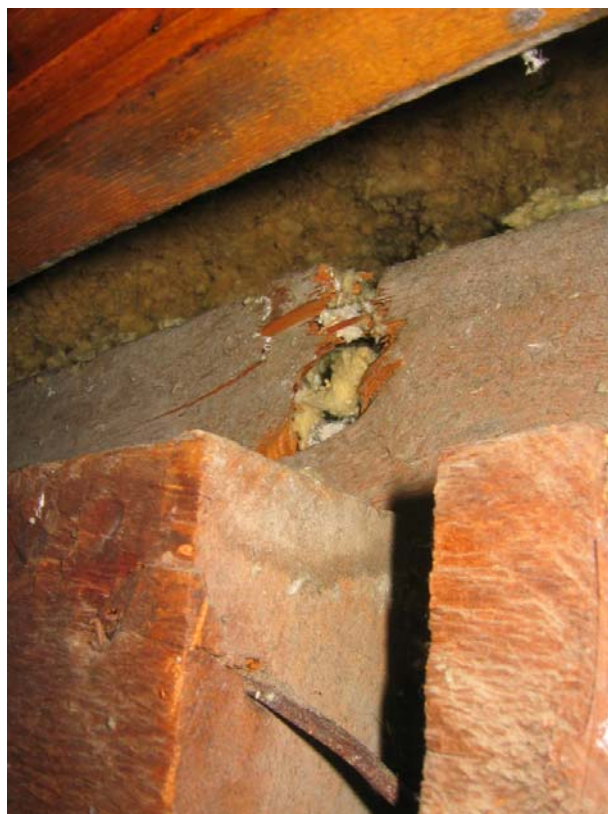
**Figure 12.** Split bottom chord, west end of failure
