# The Structural Investigation of a 19<sup>th</sup> Century Manufacturing Complex

By D. Matthew Stuart, P.E., S.E., F. ASCE, SECB

## Project Overview

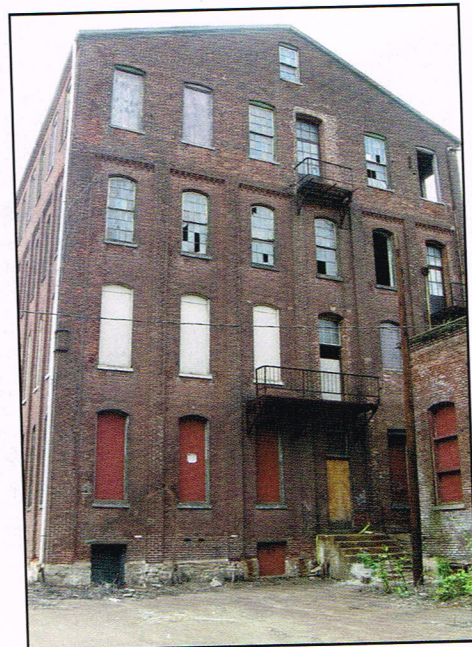
Typical Building Elevation.

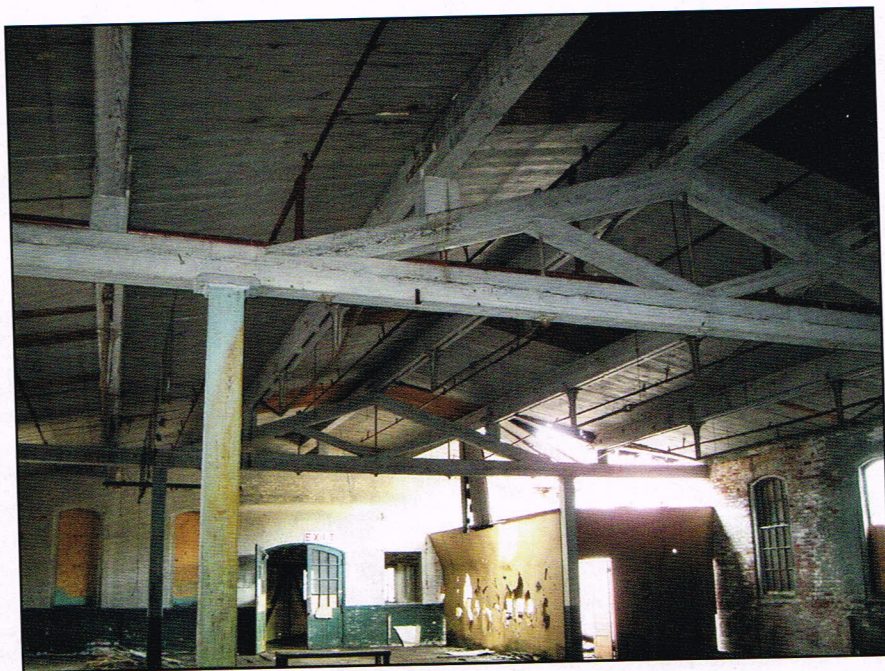
Queen Post Truss Spanning Between Gable Truss.

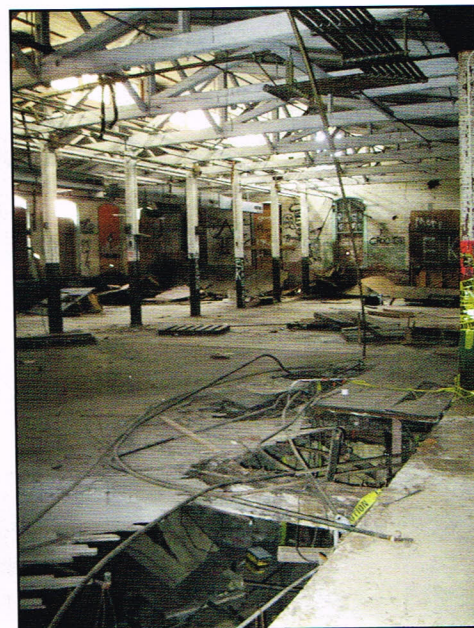
*Collapsed 1<sup>st</sup> Floor Framing over Basement.*

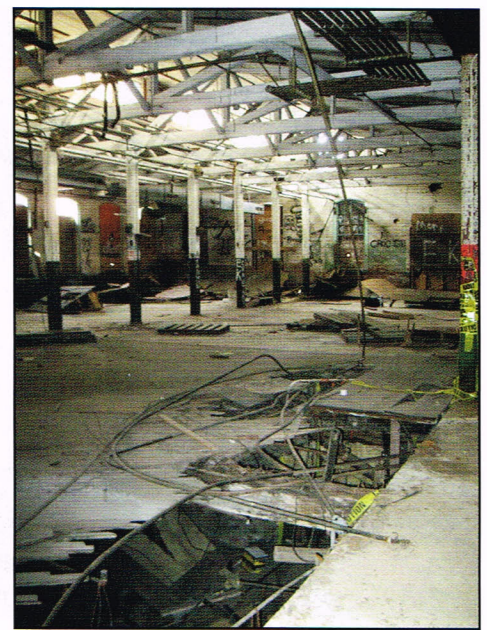
*Collapsed 1<sup>st</sup> Floor Framing over Basement.*
