Vintage Timber Truss Roofs: Claims Waiting to Happen

By David B. Tigue and Kurt R. Hoigard

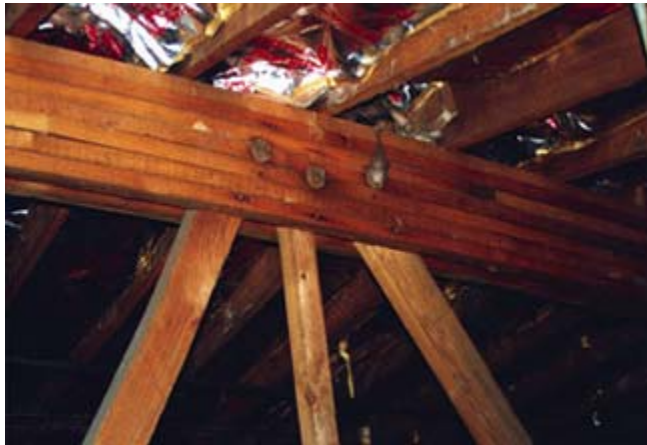
A variety of timber roof truss configurations have been used over the years. One of the most common types is the bowstring truss, so called because of its arched top chord profile (see Figure 1). Roofs constructed with bowstring trusses became popular in the late 1930s, and are readily identified by their curved shape. Although several

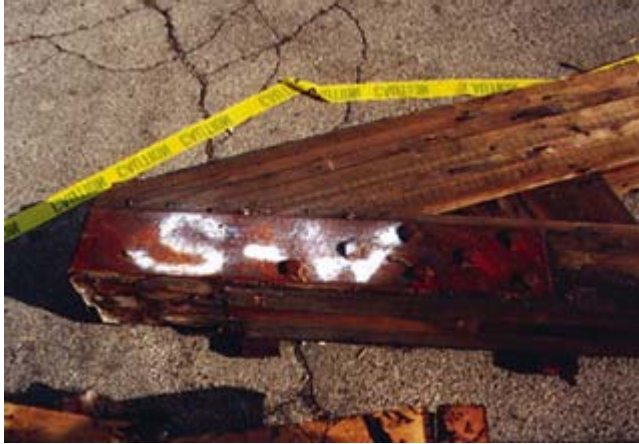
construct both the top and bottom chords with two parallel members. In this arrangement, the web members were sandwiched between the chords and connected with bolts (see Figure 2).

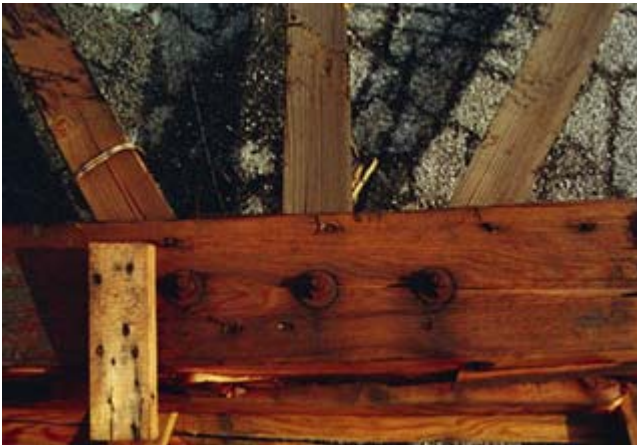
located near mid-span, to achieve the required length. The top and bottom chord members were fastened together at the truss ends with U-shaped steel heels, or end shoes, bolted to both chord members (see Figure 3).

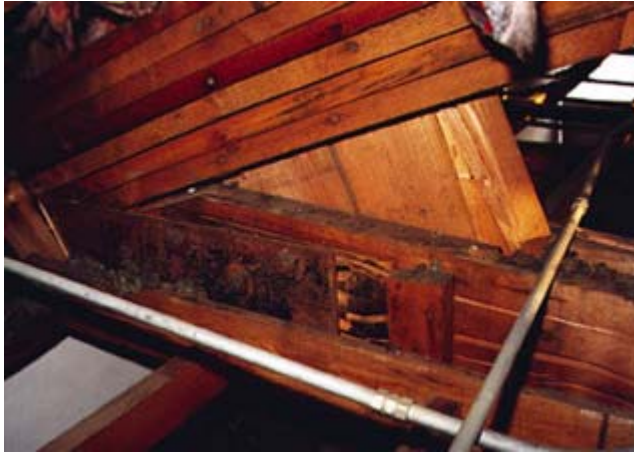
Unfortunately, the analytical methods typically employed prior to the widespread availability of computerized structural analysis programs in the 1980s did not fully consider the effects of member continuity, connection eccentricity (the offset between theoretical member center lines and the actual connection points) and the semi-rigid nature of multiple-fastener connections. These conditions can combine to produce actual truss member stresses significantly

higher than those anticipated by the original designer, and frequently result in connection splitting failures that ultimately endanger the entire truss (see Figure 4).

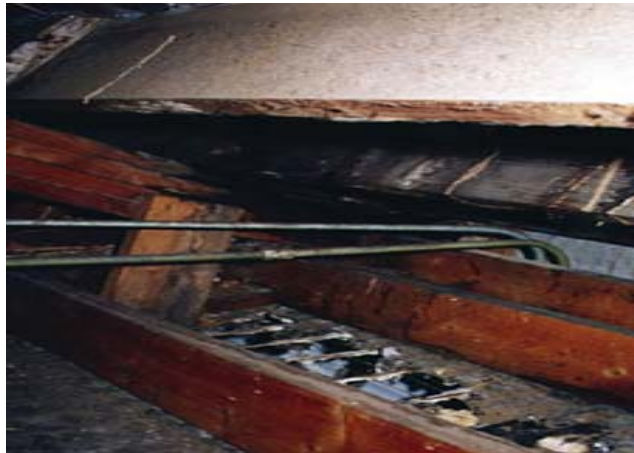
The end connections on bowstring trusses are critical to the overall truss performance. The bolted, steel, U-shaped end shoes at these locations transfer large thrust loads from the top chord members into the bottom chord. Rot and decay cause the wood to soften and lose strength, resulting in

top-chord shortening from crushing against the steel shoe, localized sagging of the bottom chord, and elongation or splitting of the end shoe bolt holes (see Figure 5). Long-term deterioration of truss ends often results in failure of these connections and consequent loss of truss action. When the end connections deteriorate or fail, the outward thrust from the top chord is no longer resisted by the bottom chord. Instead, thrust loads push outward against the supporting masonry walls, resulting in bowing of the walls and--if left unchecked--complete collapse of the roof.
