# ENGINEERING FOR HERITAGE MASONRY

By Michael Schuller, P.E. and Glenn Boornazian

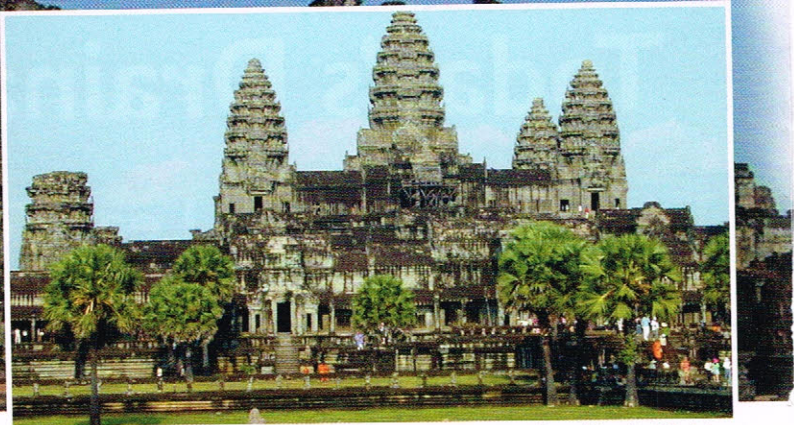
Figure 1: Conservation of the stone roof structure being conducted by the World Monuments Fund at the "Churning of the Sea of Milk" gallery, Angkor Wat, Cambodia. Courtesy of the World Monuments Fund.

Nearly all of the world's remaining ancient monuments contain some type of masonry. Working with historic construction involves carefully balancing engineering objectives with preservation principles and increased analytical efforts to make the best use of existing construction. The authors have had opportunities to apply these concepts to preservation of several heritage masonry structures, including work for the World Monuments Fund (WMF), [www.wmf.org](http://www.wmf.org), at the temple of Angkor Wat (Figure 1).

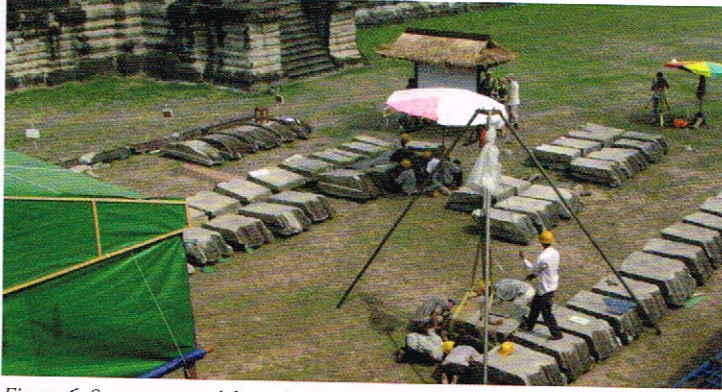
Figure 6: Stones removed from the Angkor Wat roof structure being conserved in the on-site workshop. Courtesy of the World Monuments Fund.

Originally constructed in the 12<sup>th</sup> century, the gallery's corbelled stone roof structure was built with a series of massive sandstone blocks, dry-laid without mortar in an interlocking fashion (Figure 6). Work on site focuses on restoration of the roof structure's original passive drainage
