## Reinventing 690 Market Street

Historic Structure Reclaimed, Vertically Expanded

## Tips for Reducing RFIs

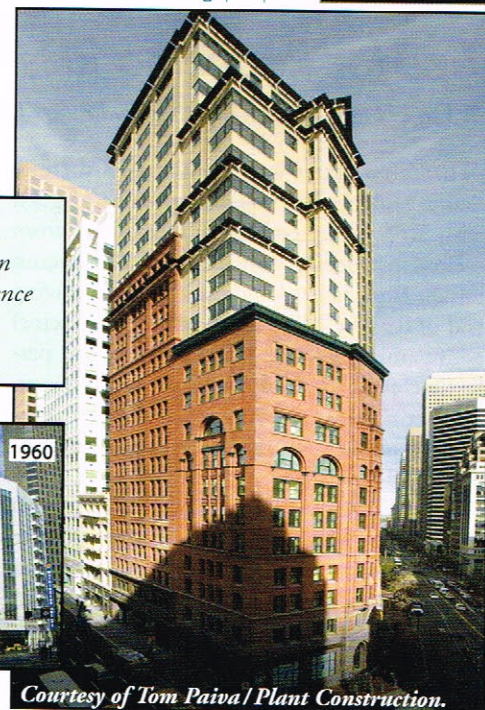
Courtesy of Tom Paiva/Plant Construction.

A new 5-foot mat foundation integrated various pre-existing foundation elements, and supports the additional gravity loads and over-

turning moments associated with the vertical expansion. Since the new building has multiple setbacks, transfer girders consisting of double and triple beams support the transfer columns. Special details connect these girders to the concrete-encased cast iron columns. Given the complexity of this project, the outcome was highly successful. Even with complications during demolition and analysis phases, the project was built on schedule. The structural design was also a large factor in achieving budget goals, which are critical to housing projects.
