# CM Found Not at Fault in Negligence Case

## SBCRI Provides Testing Services to Disprove Product Defect Claims

by Kirk Grundahl, PE, & Libby Maurer

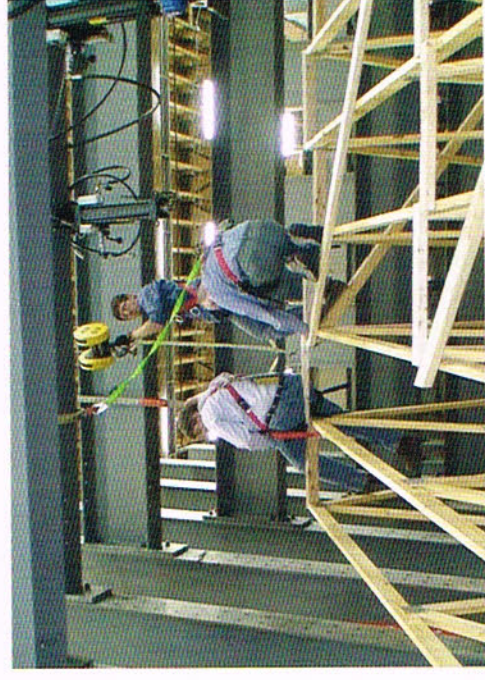
First, the trusses were properly installed and braced per BCSI.

Next, three men were positioned at the top of the truss (as shown in photo above), representing three times the load at the peak of the truss on the jobsite. Two additional men stood on each bearing end of the truss. This is where they stood on the jobsite when installing temporary bracing. With the load of five men on the truss, it did not fail.

Then to simulate the broken knot area, a hole was cut in the bottom chord of A2. The same five men climbed onto the truss. No failure.

Then a cut was made through the bottom chord of the first “knot” and loaded with five men. No failure.

Finally, the bottom chord was cut all the way through at the “knot.” Again, the truss did not fail.

The process of creating a hole, making cuts straight through the chord, and loading the truss with five men was repeated to simulate the second knot in the bottom chord. As with the previous set of tests, the truss did not fail. In each of the cases, the truss never failed to support the load that was applied to it.
