Vintage Timber Truss Roofs: Claims Waiting to Happen

By David B. Tigue and Kurt R. Hoigard

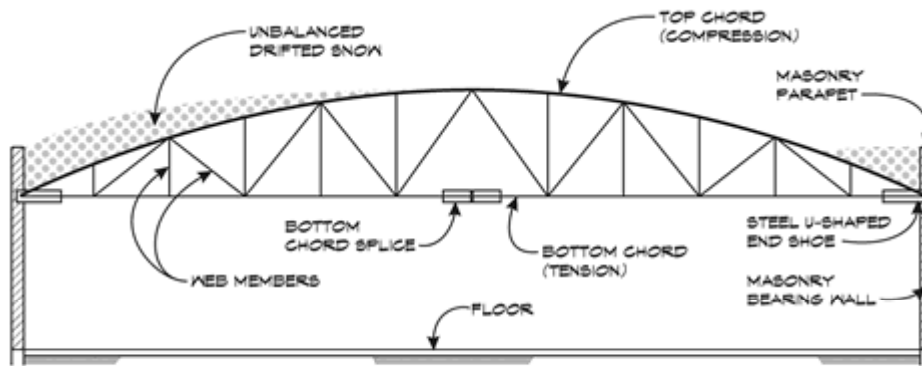
Buildings with heavy timber roof trusses can be found in many urban areas. Common in buildings constructed from the 1920s through the 1950s, timber roof trusses utilized large pieces of wood bolted together to form open spans, frequently longer than 70 feet. Timber roof trusses can be found in almost any kind of building, but were mostly used for single-story industrial and commercial buildings requiring large, open floor spaces. Examples include manufacturing facilities, warehouses, grocery stores, bowling alleys and roller rinks.
