SCHNITZHOFER & ASSOCIATES, LLC

DECEMBER 2011 NEWSLETTER

CASE STUDY: SAVING HISTORIC STONE LINTELS

HISTORIC RESIDENTIAL RENOVATION - LEXINGTON, VA

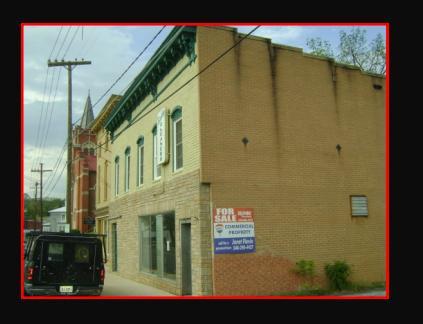
307 NORTH AUGUSTA STREET - STAUNTON, VA

REINFORCING NEW OPENINGS IN THE LOAD BEARING WALLS. SEE BEFORE & AFTER PHOTOS AND THE REINFORCE-MENT OF THE HISTORIC BRICK AT THE

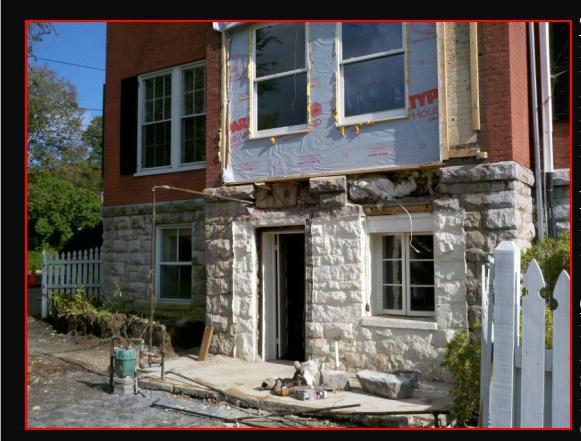
THE PROBLEM: IRREPLACEABLE STONE LINTELS HAVE EXPERIENCED DETERIORATION AND DAMAGE OVER THE YEARS. AS A RESULT, FAIL-URE HAS OCCURRED RESULTING IN THE PHYSICAL DISLOCATION OF THE LINTELS. AS YOU CAN SEE IN THE PHOTO TO THE LEFT, BOTH STONE LINTELS ARE LYING ON THE SLAB ON GRADE BELOW THEIR ORIGINAL LOCATIONS.

WHAT WE HAVE TO WORK WITH: LEFT FOR US TO WORK WITH ARE DAMAGED AND BROKEN AUTHENTIC LINTELS. THE LINTELS ARE SOLID BUT UNFORTUNATELY REST ON THE GROUND IN MULTIPLE PIECES.

OUR OPTIONS: WE HAVE A FEW ALTERNATIVES AVAILABLE. PRECAST MASONRY LINTELS WITH SPLIT FACE FAUX STONE VENEER WOULD ACCOMPLISH A NEARLY PRESERVED AESTHETIC CONDITION, WHILE SATISFYING OUR STRUCTURAL REQUIREMENTS. IN OUR CASE, WOOD LINTELS CLAD IN SPLIT FACE VENEER ADDRESSES STRUCTURAL CON-CERNS, HOWEVER INTRODUCING WOOD MATERIALS INTO A BRICK AND

STONE STRUCTURAL SYSTEM IS UNDESIREABLE DUE TO MATERIAL INCOMPATIBILITY, DETERIORATION RESULTING FROM ROT, MOIS-TURE INTRUSION AND RETENTION, AMONG OTHER CONCERNS. FOR THIS BEAUTIFUL HISTORIC RESIDENTIAL PROJECT, WE CHOSE TO REPAIR THE EXISTING LINTELS.

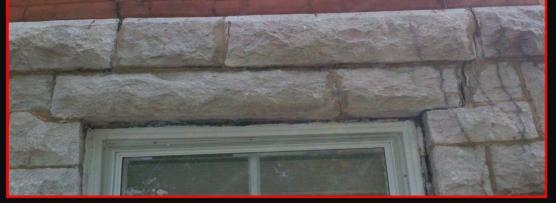
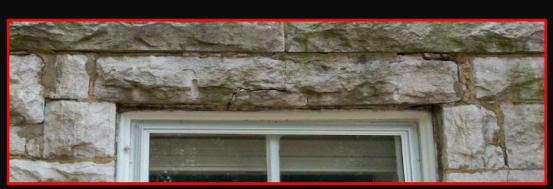
STRUCTURAL ANALYSIS: WE APPROACH THE STRUCTURAL ANALYSIS OF THE STONE LINTEL REPAIR FROM A CLASSICAL PERSPECTIVE. ASSUM-ING COMPARABLE MATERIAL PROPERTIES BETWEEN STONE AND CON-CRETE (FOR APPLIED STRESSES WITHIN ALLOWABLE CONCRETE COM-PRESSIVE STRENGTH RANGES), WE CAN MODEL THE BALANCE OF TEN-SILE AND COMPRESSIVE COUPLING SIMILAR TO THAT OF A NON-RESTRESSED REINFORCED CONCRETE BEAM. UPON VERIFICATION THAT OUR MODEL COMPLIES WITH OUR ASSUMPTIONS, THROUGH COMPUTA-TION, WE REPLACE OUR BEAM/LINTEL MODEL CROSS SECTION WITH CONCRETE AND PLACE MILD REINFORCEMENT IN THE TENSILE ZONE TO RESIST BENDING STRESSES. 5/8" WIDE X APPROXIMATELY 3" DEEP SAW-CUT CHANNELS ARE SCRIBED ALONG THE BOTTOM OF THE RE-ALIGNED BROKEN LINTEL SECTIONS. NEW STEEL REINFORCEMENT IS THEN PLACED WITHIN THE GROOVE, IN EFFECT, RECREATING A BEAM TO RESIST INTERNAL BENDING STRESSES.

MATERIALS: BONSTONE MANUFACTURES TWO-PART STRUCTURAL

FORCING STEEL AND STONE AND CONCRETE MATERIALS. DEVELOPMENT CAPACITIES HAVE BEEN TABULATED BY BONSTONE, ALLOW-ING US TO DETERMINE THE REQUIRED DEVELOPMENT LENGTH, AND EASILY VERIFY THAT THE STRESSES CAN, IN FIACT, BE TRANSMIT-TED. FOR THE PURPOSES OF THIS STONE LINTEL REPAIR PROJECT, OUR STRESSES WERE WITHIN TOLERABLE LIMITS, SO DEVELOPMENT WAS EASILY ACCOMPLISHED. SCHNITZHOFER & ASSOCIATES, LLC IS CONSTRUCTING QUICK REFERENCE TABLES DENOTING RE-QUIRED EXPOXY/REINFORCEMENT INTERACTION DEVELOPMENT LENGTHS FOR VARIOUS SPAN, MATERIAL AND LOADING CONDITIONS FOR USE WITH FUTURE PROJECTS.

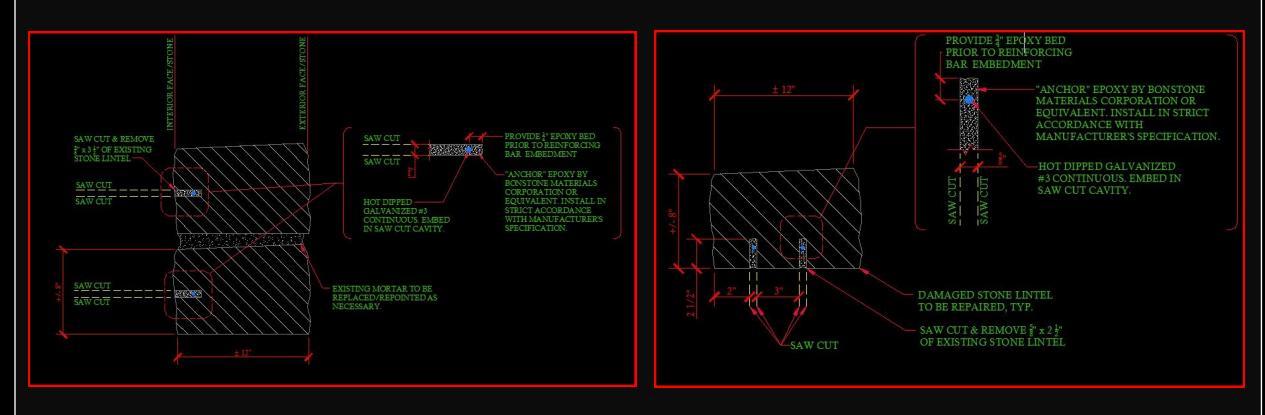
<u>FINISHED PRODUCT:</u> While construction is not complete as of 12.01.2011, we anticipate the lintels to have the appearance of solid and working structural lintels, with adeuate capacity to resist vertical loads acting upon them.
